A STUDY OF ROADWHEEL FAILURES MAGNITUDE - NATURE -
CAUSES AND TESTING OF A CONCEPT TO PREVENT THEM

John W. Cameron

TECHNICAL REPORT NO. 12080

FINAL REPORT

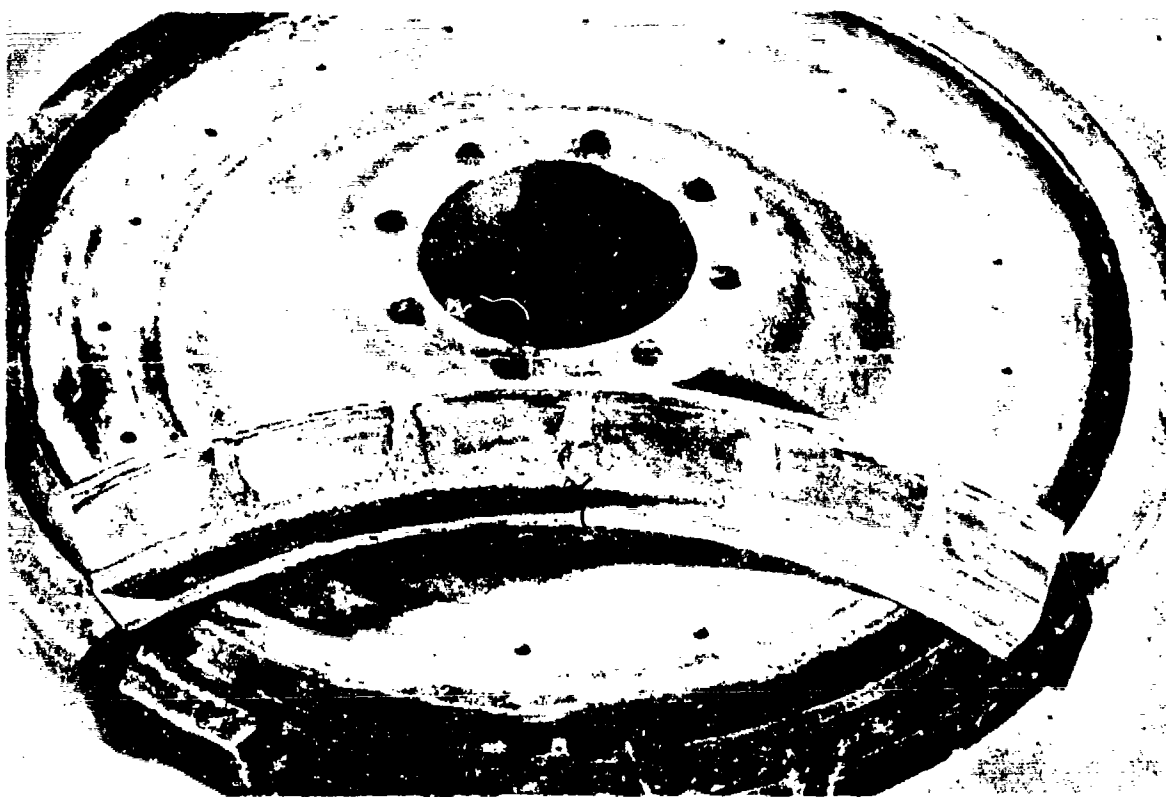
FIGURE 12 - Wheel #2 on Which Shroud Was Cracked but Still Not Broken After 998 Miles. Section Was Sawed From Shroud to Study Crack.
